A case study on identifying, locating, and eliminating radio frequency interference (RFI) caused by 60 Hz power lines.

Eliminating Radio Frequency Interference from Power Lines

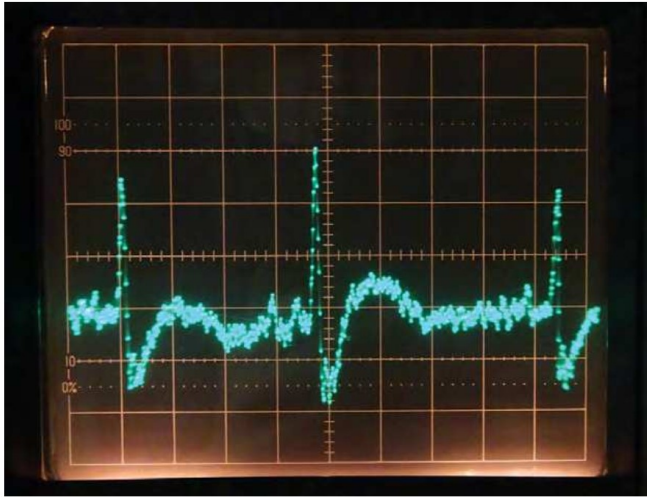
Figure 1 — The oscilloscope display of the power line noise signature at the audio output of IC-7700 receiver, 2 ms/div.

With the scope synced to the power line frequency of 60 Hz, the noise exhibited pulses at a steady 120 Hz rate, indicating that the source of the RFI is the 60 Hz power system. The timing and duty cycle of RFI always provides a clue as to the source. The manual¹ for the Radar Engineers model 243 RFI Locator instrument describes how power line-induced arcing is created.

A positive identifier was the audio signature seen on an oscilloscope (see Figure 1) at the receiver audio output (see Figure 2) and on the Icom IC-7700 receiver spectrum display, using the AM detector, with 6 kHz bandwidth. See also Figure A on the *QST* in Depth web page.

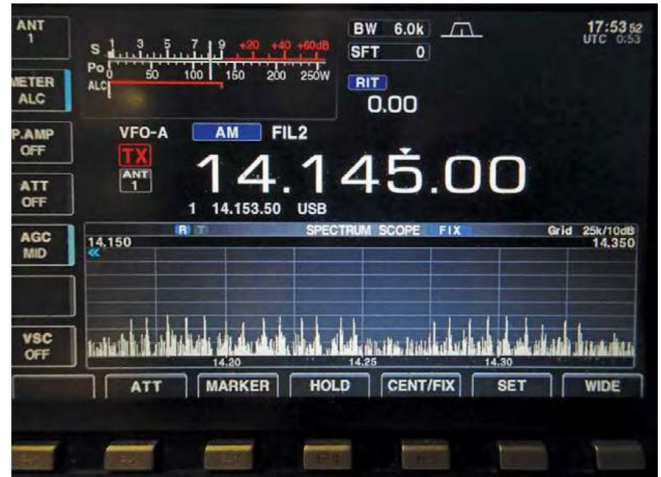
Figure 2 — The Icom IC-7700 receiver power line noise S-8 reading, and spectrum display, using the AM detector, with a 6 kHz bandwidth.

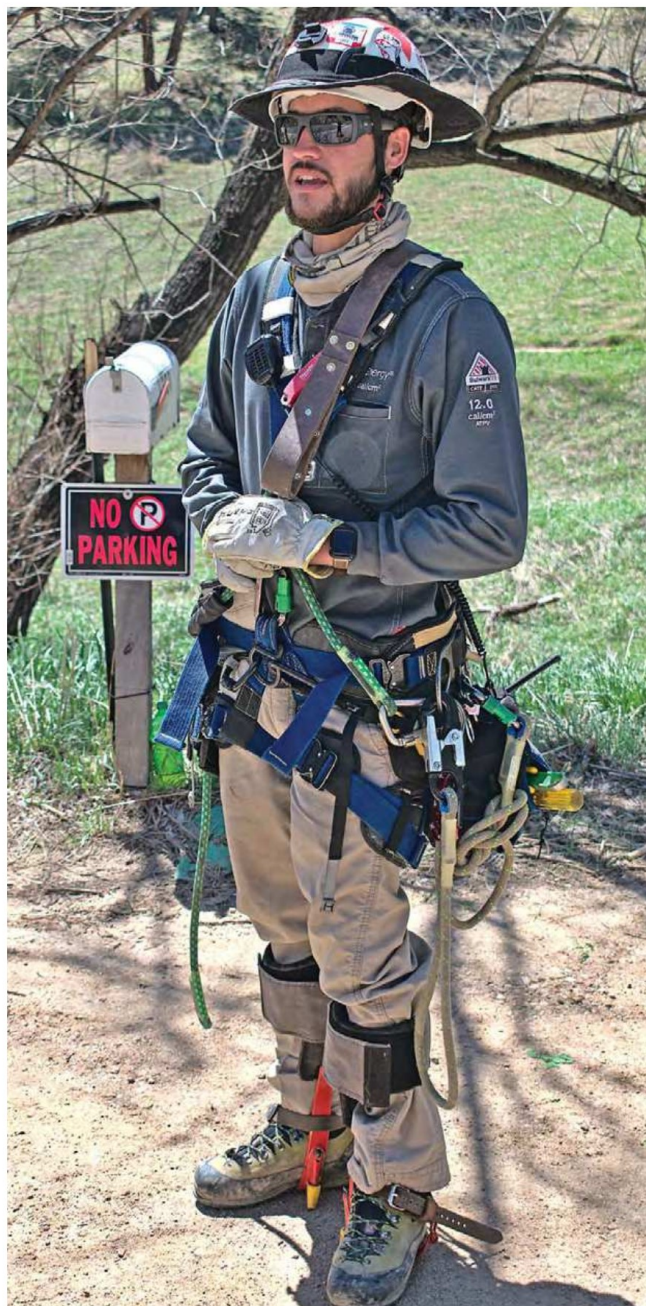
Figure 4 — A well-equipped lineman ready to climb the power pole with spikes.

A few weeks later, three Xcel Energy line crew members (see Figure 4) were air lifted by helicopter to the hillside location of the pole to fix the problem by splicing the ground wire, reconnecting the hardware, and tightening the bolts on all metal hardware. As soon as the transmission line was energized, the RFI had been fixed with no more noise on 20 meters.
